LEVEL 3

Your survey report

[REDACTED]
[REDACTED],
[REDACTED],
[REDACTED],
[REDACTED]

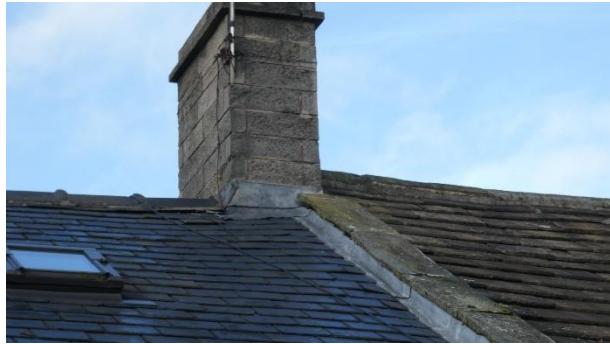
Figure 3 - Left chimney stack with contrasting stone

The chimney stack features a single clay pot to the front flue which serves the log burning stove within the reception room. The rear flue has been closed off by a square stone flag laid over the flue and bedded in mortar. It is expected that this would have originally served an open fireplace within Bedroom 1. The closed flue is not ventilated from inside or at the external capping. The lack of ventilation within a chimney flue can result in condensation forming inside the flue. The condensation is then absorbed by the surrounding masonry and can be drawn through to the outer face of the stone together with salts and soot from previous fires, leaving dark damp stains to walls or chimney breasts. Such dark stains were evident within the roof space below this chimney stack, with contrasting cleaner masonry in line with the flue which continues to serve the log burning stove (Figure 2). The use of the log-burning stove will help to dry the masonry along the line of the flue, thereby preventing this staining.

For this reason, we would recommend that all disused flues be ventilated from both the top and bottom. This could be provided by adjustable vents fitted to blocked off fireplaces internally. Externally, the stone caps would need to be removed and a clay ventilated chimney cap instead fitted over the flues. These would need to be provided in keeping with the historical aesthetic of the building. The use of reclaimed clay chimney pots, either in a Bishop or Crown style would match existing pots and would likely be acceptable to the conservation officer. The chimneys should then be capped with a removable cap which allows ventilation into the flue while preventing birds/water ingress from above.

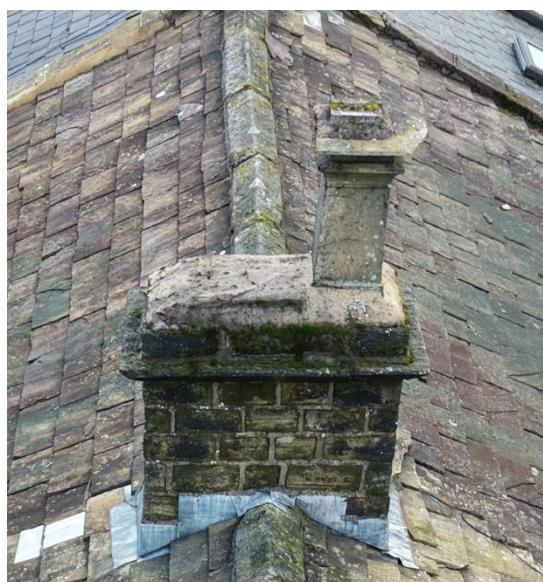
2. The central chimney stack has an aged, buff coloured square chimney pot to the rear flue. This has been covered with a large stone slab, topped with concrete blocks set in mortar (Figure 4).

Figure 4 - Central Chimney Stack

The chimney pot was seen to have surface cracking evident. The front flue of this stack has been capped and covered with mortar. This chimney serves the fireplace within the Dining Room and based on the evidence available, is also believed to have once served a fireplace within the cellar, most likely for cooking or additional heating. The flue within the cellar remains open to the underside but has been capped off with stone at ground floor level. It is not possible to determine which flue serves which fireplace. Given the position of the fireplaces, we would assume that the capped, front flue serves the fireplace of the Dining Room. This has again been capped off internally with cementitious boards. Gaps in the boards allow for ventilation of this flue from within, but again, no ventilation is provided at roof level.

The stone capping of the chimney pot appears to be precariously balanced on the pot with minimal weight to retain it. The large overhang would, in our opinion, make it susceptible to wind uplift. However, it has evidently remained in place for many years and so is could be expected to continue to do so. If the mortar bed of the ballast were to deteriorate, there could be a risk of the stone and blocks on top falling from the roof. If the flue were to remain unused, we would therefore consider taking the unused chimney pot away and capping the unused flue with a ventilated cap.

It may be preferable to install an additional log burning stove within this room. If this were desired, the flue should be lined in accordance with the Building Regulations, and a new chimney pot would be required at roof level due to the age of the existing it would not be considered useable for a new appliance. This would require the existing capping/chimney pot to be removed and replaced.

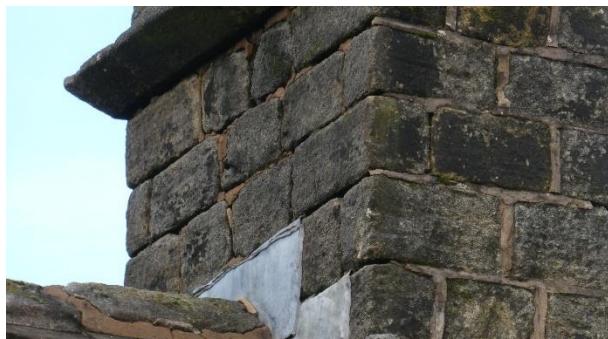
The stonework of the chimney is evidently original but has been repointed in patches, with contrasting mortar mixes used. It appears that when repairs have been made to the roof ridge, excess mortar has been used on the left side of the chimney. Despite this, the mortar joints are heavily weathered to the left, western face of the chimney (Figure 5).

Figure 5 - Weathered mortar to central chimney stack

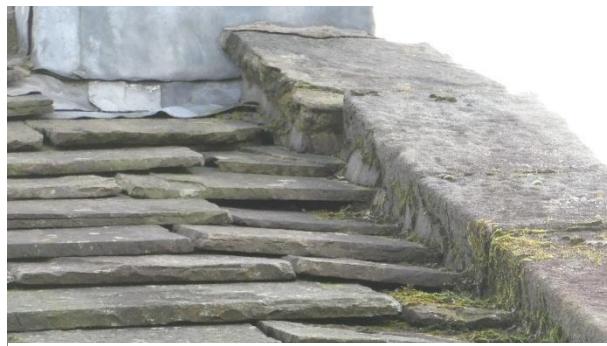
To the rear slope, the roof line drops slightly towards the parapet. This is due to a variation in height between the roof slating battens and the gable wall below this area. The larger gaps in the slates at this position will result in an increased potential for water ingress to occur, particularly from wind driven rain.

Figure 9 - Rear roof slope at western parapet

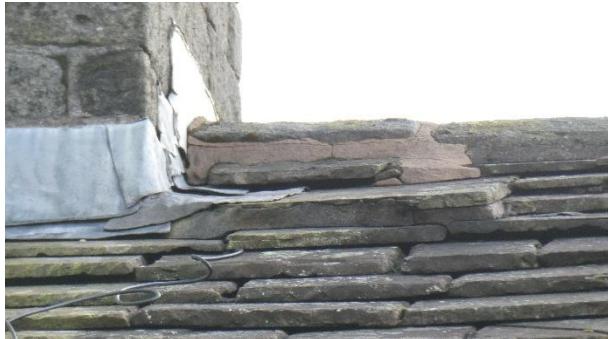
To the rear slope, the stone slate to the right of the central chimney stack was seen to have a mortar fill below.

Figure 10 - Mortar fill below slate to rear slope

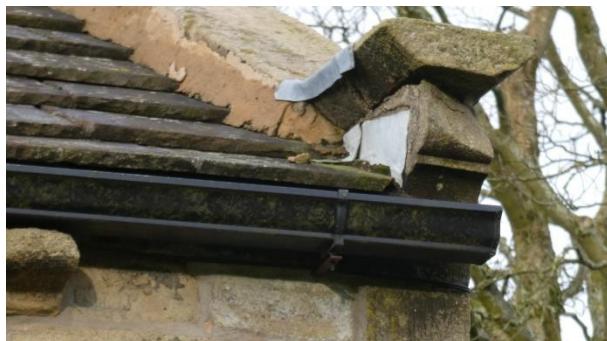
Figure 12 - Stone kneeler to front right roof parapet

Mortar fillets weathered the abutment between the roof slope and the inside face of the parapets (Figure 12 & Figure 13). Mortar fillets were again of contrasting materials suggesting that some have been repointed more recently, again in what looked to be modern cement based mortar.

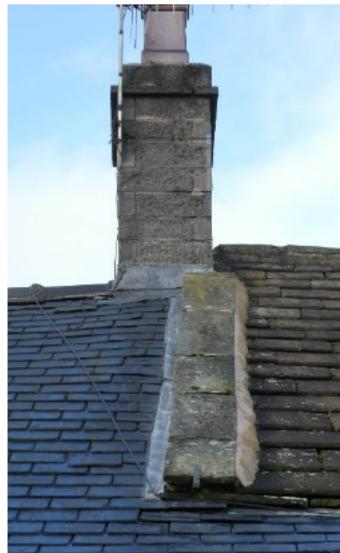
Figure 13 - Front left parapet with angle bracket support

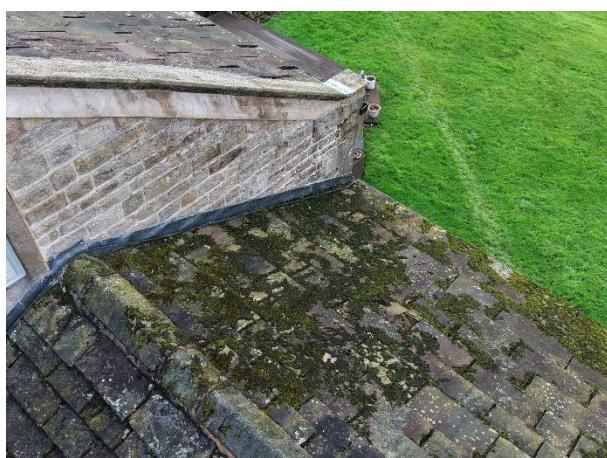
The ridge of the lower roof was again seen to be stone ridge tiles in a cement based mortar bed. Although the mortar bed was seen to be in a reasonable condition, we would recommend that when this needs to be renewed in the future, the ridge tiles be bed onto lime mortar.

Figure 14 - Low level pitched roof over Bedroom 3

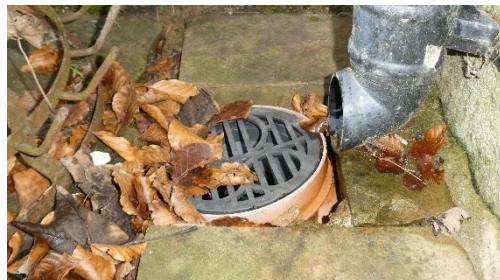
The rainwater downpipe to the front of the property discharges into the gully of the drain at ground level. However, the shoe of the downpipe finishes short of the gully resulting in water washing out the mortar of the paving and drainage around the gully (see Section F6 below).

Figure 17 - Rainwater downpipe to front of property

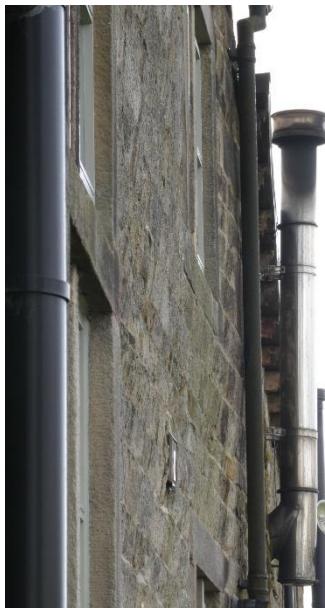
Walls were seen to be in a reasonable condition with no evidence of ongoing movement. However, the rear external wall was seen to have a significant bow where it meets with the neighbouring barn conversion (Figure 20). No signs of cracking or movement as a result of this were identified and so this we believe this to be historical settlement of the building requiring no further action.

Figure 20 - Bowing of rear wall at abutment to neighbouring barn conversion

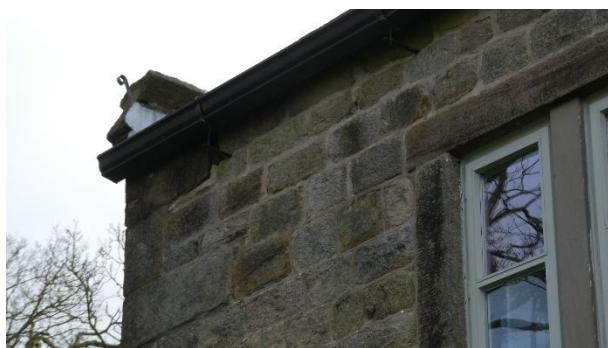
An open joint in the stonework was seen to the side of the stone quoin to the corner of the rear elevation (Figure 21). This isolated opening should be repointed at the earliest opportunity to prevent water ingress into the wall. Again, this should be completed with lime mortar.

Figure 21 - Open joint in stonework to upper rear corner

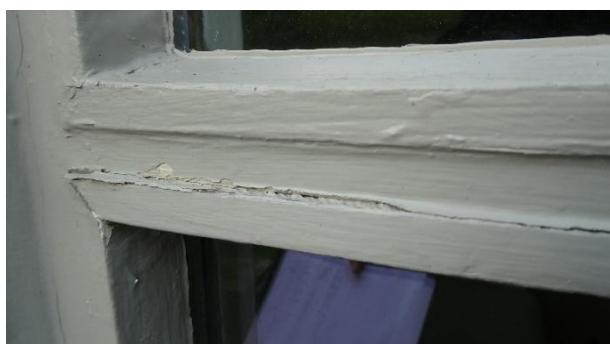
All windows were found to be in a reasonable condition. External decorative finishes to timber framed windows were beginning to flake and peel. Allowances should be made to redecorate the windows within the next 2-3 years and thereafter at regular intervals.

Figure 24 - Peeling painted finish to timber window frames

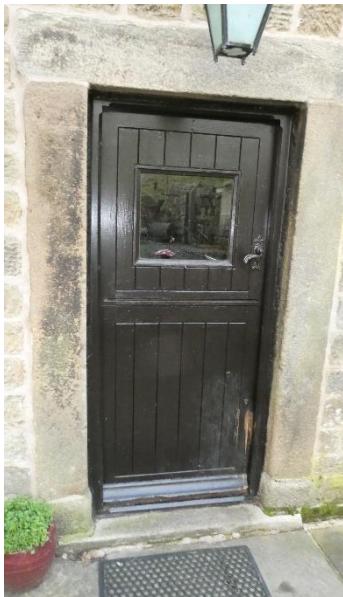
The door was found to be in a reasonable condition, although the external decorative finish has been worn to the leading edge of the lower half of the door. This appears to be due to animals (dogs) scratching at the door. We would recommend that the door be redecorated to preserve the timber from weather as soon as possible.

Figure 25 - External door to kitchen

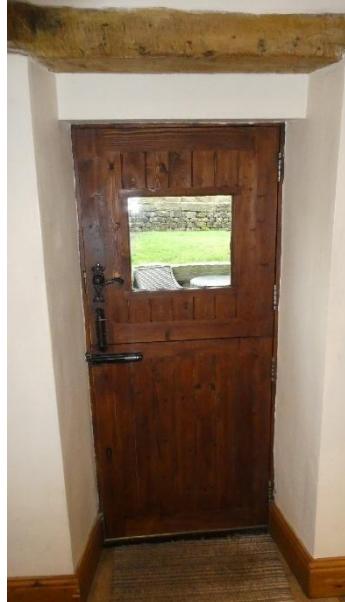
The door was found to operate freely although the barrel bolt to the lower half of the door did not align with the catch on the door frame. Adjustment of the ironmongery would be required to allow this to be used for increased security.

Figure 26 - Internal side of kitchen door

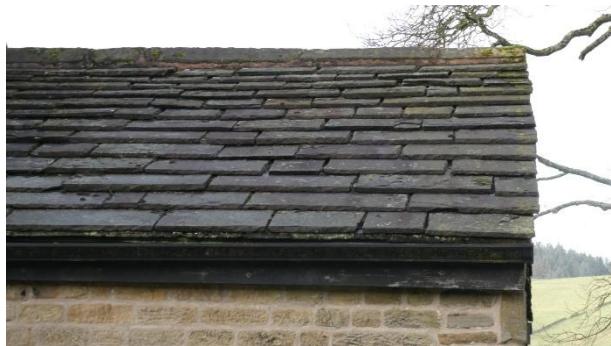
The timber fascia boards were noted to have faded decorative finishes. We would recommend that to preserve the timber from the weather and prevent rotting of the fascia boards, these should be redecorated as soon as possible and allowances be made to repeat this at regular intervals thereafter.

Figure 27 - Faded decoration to fascia board to front of kitchen

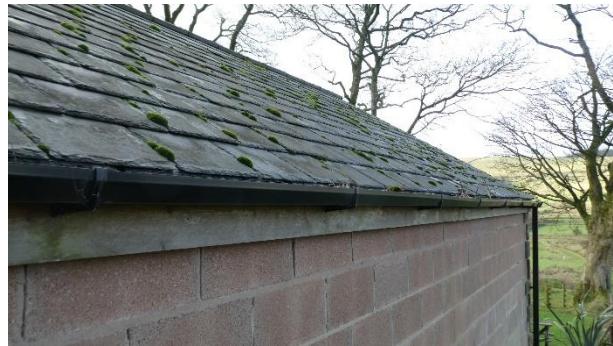
The eaves of the garage is also fitted with timber fasica boards. These lack decoration but appear to be formed with treated timber. Despite this, to ensure the greatest longevity of the fascias, we would recommend a protective finish be applied to the fascia boards.

Figure 29 - Fascia to rear of garage

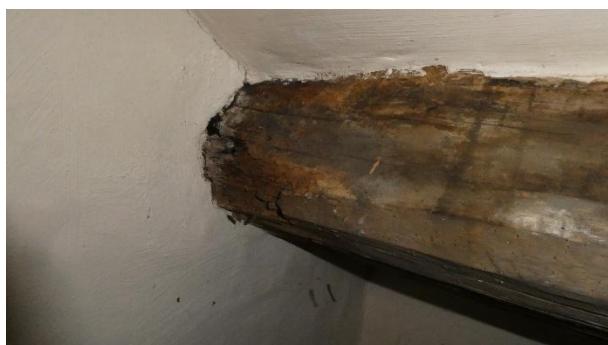
The timber purlins within the central Storage area were seen to be damp where they were supported on the internal stone wall.

Figure 34 - Lower front purlin within Storage area

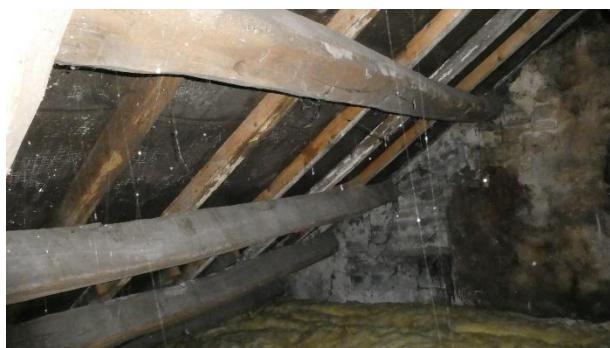
Again, timber purlins appeared to be of significant size, although the lower purlins below the front roof slope appeared to have some deflection along their length. This was not replicated in the roof line above and so in our opinion this is a natural irregularity in the line of the timber and not a result of excess weight applied from the roof coverings. We would nevertheless recommend that the condition of these purlins be inspected close up during any re-roofing works.

Figure 37 - Purlins below front roof slope

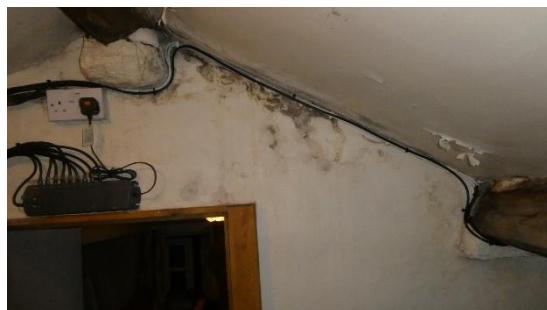
Within the roof void, plastered ceiling finishes have been applied to the underside of the rafters between purlins within the Attic Room and Storage area. These were seen to be in a reasonable condition, although the lack of insulation and ventilation created by this construction is noted below (Sections J1 & J4). Peeling paint was seen to the ceiling of the Storage area near to the evidence of water ingress at the internal solid wall. This is due to dampness and humidity within the roof and once resolved, the painted finish should be redecorated.

Figure 38 - Peeling finish of ceiling in roof void Storage area

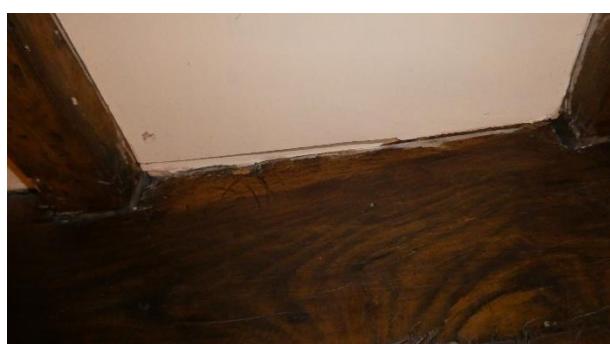
Where plastered ceilings abut timber elements, or at some ceiling perimeters, cracking was generally observed (Figure 41). This is due to the differential movement of the plastering compared with the timber or the walls. When each ceiling is next redecorated, a flexible sealant could be applied to the perimeter of each plastered section to help prevent this. However, given the movement allowed by some of the floors within the property, this may reoccur over time.

Figure 41 - Cracking between plaster and timber joists

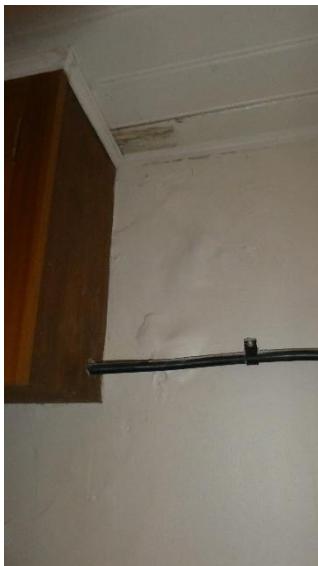
Timber clad ceilings of the entrance hall were in a reasonable condition except for some dampness noted alongside the electrical cupboard at high level. This was tested with a damp meter and found to be dry suggesting historic damage from a previous leak. The area coincided with the master bedroom en-suite shower above and no defects with the shower cubicle could be observed. We would therefore recommend that this be redecorated and monitored for future recurrence.

Figure 42 - Damp staining to side of electrical cupboard in main entrance

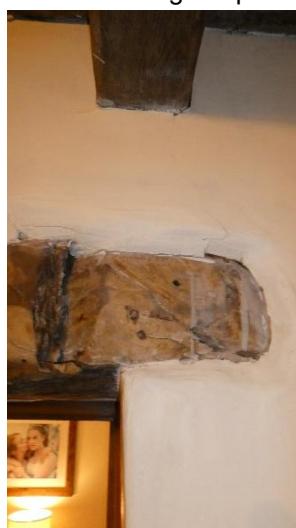
Figure 44 - Cracked and hollow plaster above door of Reception Room

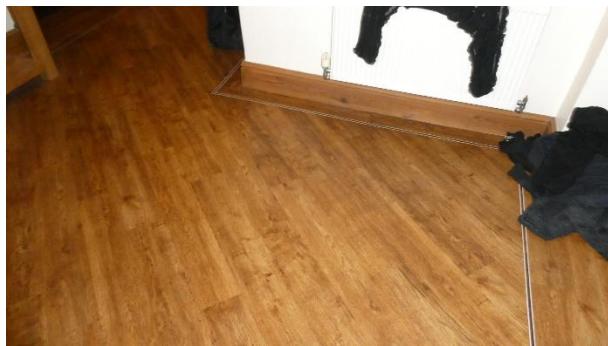
Floor finishes were seen to be in a reasonable condition throughout, although a bulge was noted to be present to the floor to the rear of the ground floor circulation area. This was most notable at the change in direction from the corridor towards the utility room and may present a trip hazard for some occupants.

Figure 46 - Bulge in floor of ground floor corridor observed in this area

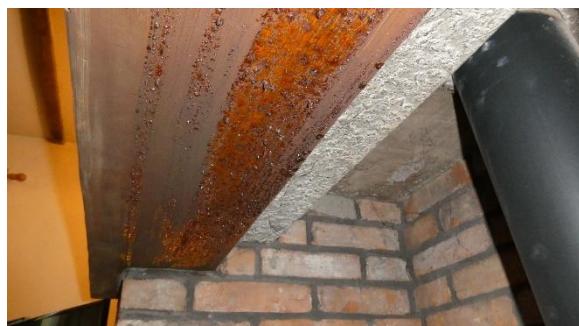
It was noted that the decorative timber mantelpiece above the opening of the fireplace showed signs of heat damage, with molten varnish to the underside of the mantel.

Figure 49 - Heat damage to varnish of mantle

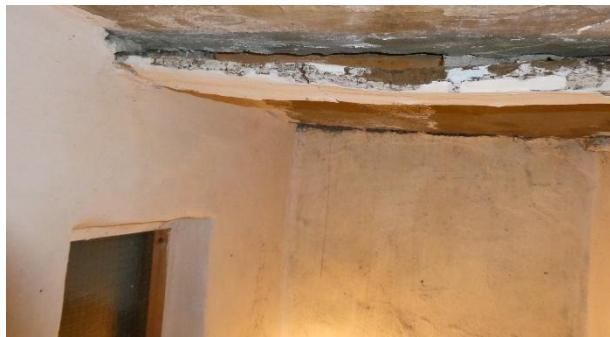
Figure 59 - Rotten timber above stairs to cellar

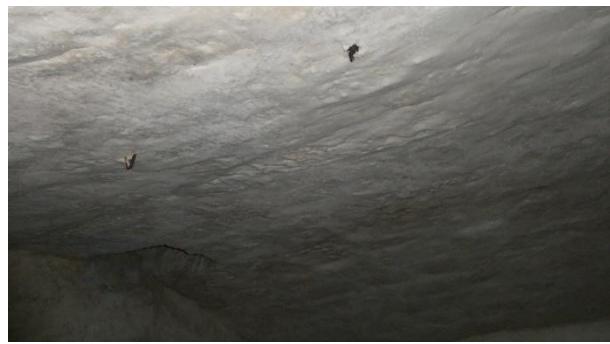
Figure 64 - Corroded fixings to ceiling of cellar

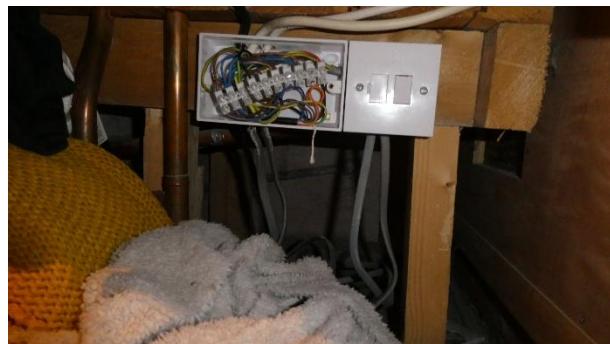
Figure 70 - Exposed wiring to junction box in cylinder cupboard

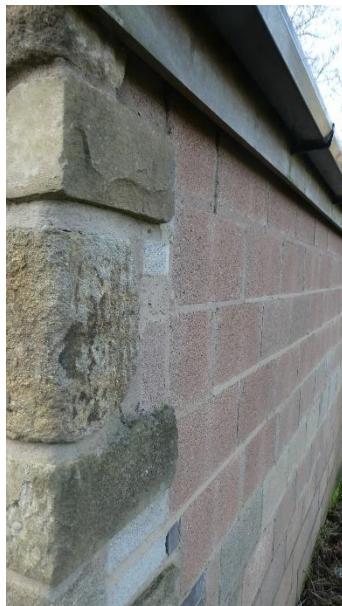
Figure 73 - Exposed blockwork to rear of garage

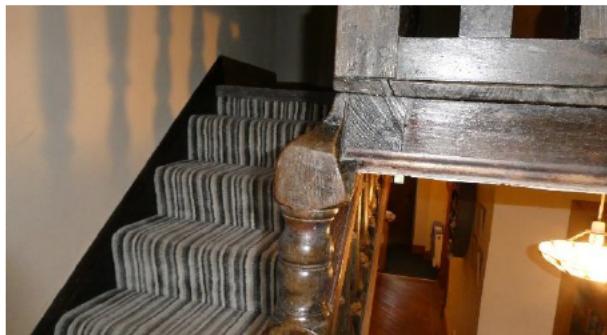
Figure 83 - First floor landing load transferred through newel post of stairs

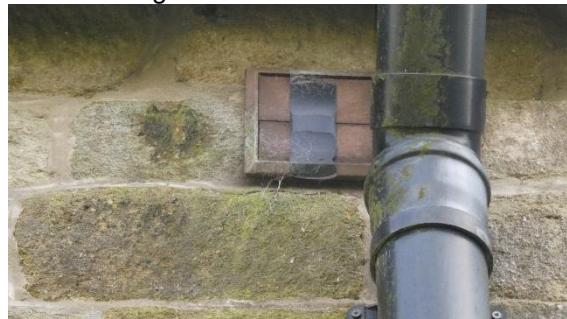
Figure 84 - Taped louvre to bathroom extract fan

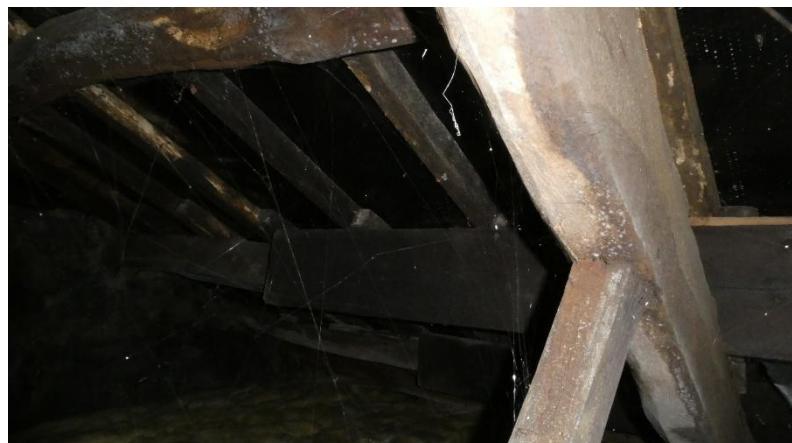
Figure 85 - Mould and condensation seen to roof structure

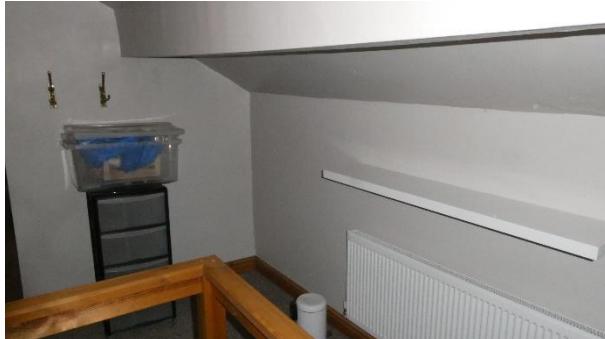
Figure 86 - Lower ceiling within roof void at higher risk of condensation forming
