LEVEL 2

Your survey report

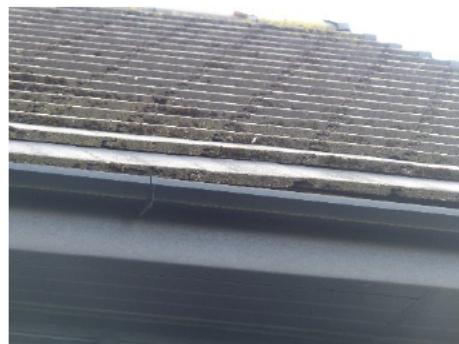
The bottom course of tiles located directly above the eaves to the ground floor mono-pitched roof and to a lesser extent on the main rear roof pitch were seen to slant down towards the gutter at a steeper angle than the rest of the roof tiles. At the time of roofing, either the fascia boards have been set too low or a tilting fillet has not been provided. This results in a gap between the lower edge of the second row and the surface of the bottom row that could allow rainwater to track beneath the tiles during periods wind driven rainfall. In this instance, the gap is quite small, and the risk is minimal. The detail could be improved by stripping back the lower courses of tiles and installing a plastic preformed eaves tray over the fascia's but beneath the sarking felt. Unless there are future issues of leakage or the need to carry out other repairs, we would advise that this repair is currently not urgent. Condition Rating 2

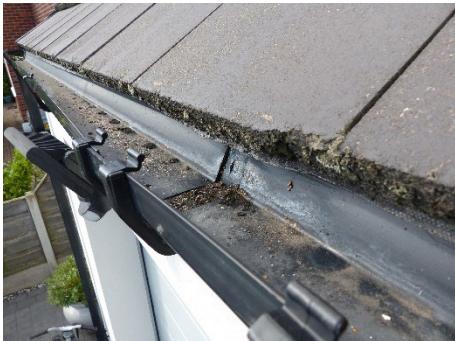
The gutter to the front elevation above the garage was seen to have slight backfall at a joint above the garage door. This will result in slight ponding of water within the gutter and ultimately the joint may leak. It will be necessary to allow for fixing additional or replacement brackets to fix the gutters and provide an adequate fall to ensure that the rainwater properly drains away.

Condition Rating 2.

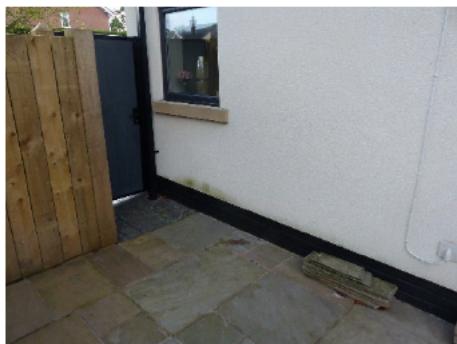
The external render finish was seen to be in a good state of repair. We did detect some minor low-level algae growth to the main left-hand elevation. This will not cause any deterioration but may become unsightly over time. This can be removed with a proprietary fungicidal wash.

Condition Rating 2

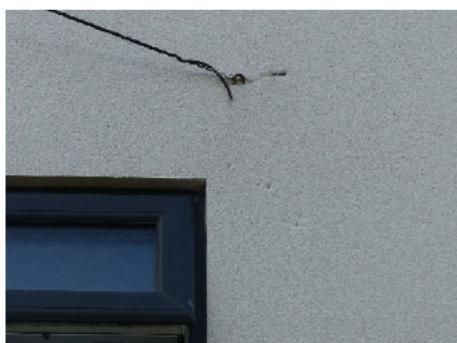
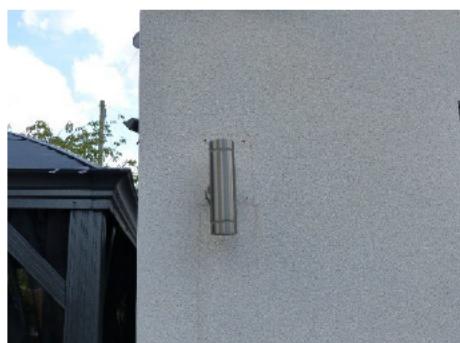
A number of holes were seen through the render finish to both the right-hand gable and main rear elevation where previous cables have been removed or where light fittings have been changed. There is a risk of water passing through these holes and getting behind the render. This may ultimately result in localised failure of the render finish. We recommend that these holes be filled with matching silicone. Condition Rating 2

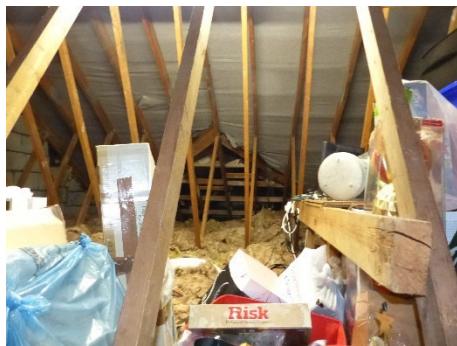
The roof does not have any wind bracing and this is not unusual for a property this age. Whilst there appears to be no significant movement, more modern properties usually have wind bracing in the form of diagonal timbers, usually 4"x1", spanning across the roof to help provide more resilience in high winds. We therefore recommend you employ a qualified Joinery contractor to install wind bracing and straps to modern standards. Condition Rating 3

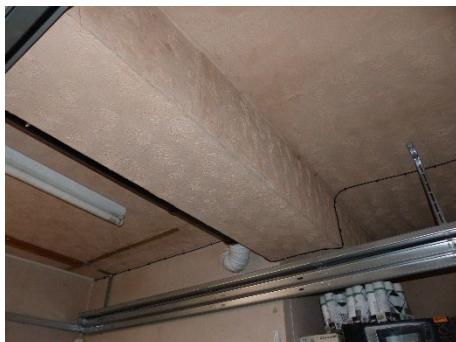
There is a textured finish to the ceiling in the ground floor front store. Textured material can contain asbestos of the type which is hazardous when disturbed. This should be of little concern, unless areas of the material are to be removed or you consider drilling or nailing into the coating, in which case this work should be implemented by an appropriately qualified contractor as it is a safety hazard. (see Section I3). This type of finish is very common in residential property. However, if this is a particular concern, you can have the coatings tested by an asbestos specialist.

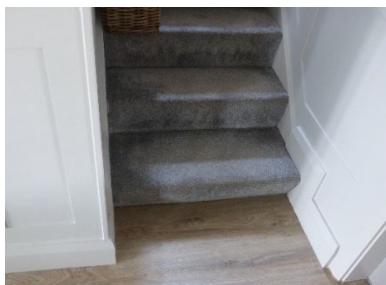
Inspection of the treads to the main staircase revealed that there is a difference in tread height of approximately 30mm between the bottom stair riser and all others. Building Regulations require that all risers have the same height to reduce the chance of trips and falls. It is possible that ground floor levels have increased slightly to allow tiles/laminate to be laid and this has in turn reduced the bottom stair riser height. There is little that can be done but you should be aware of this small difference in height. This is a safety hazard (see Section I3)

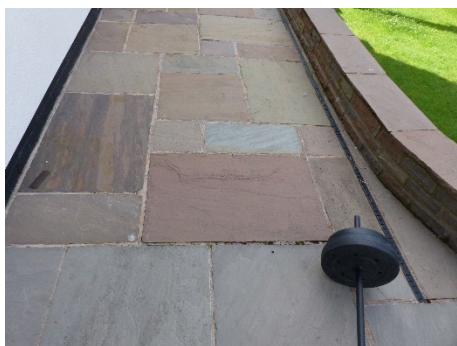
The main drive and paths to the front and left-hand gable elevation are formed from pattern imprinted concrete. The rear patio and path to the right gable are formed with York stone paving. The paved areas are generally in a serviceable condition. There is some minor cracking and weathering to mortar joints to the stone paving flags at the rear and some localised repointing will be required to prevent weed growth in the future. Condition rating 2.
