LEVEL 3

Your survey report

[REDACTED]
[REDACTED],
[REDACTED],
[REDACTED],
[REDACTED]

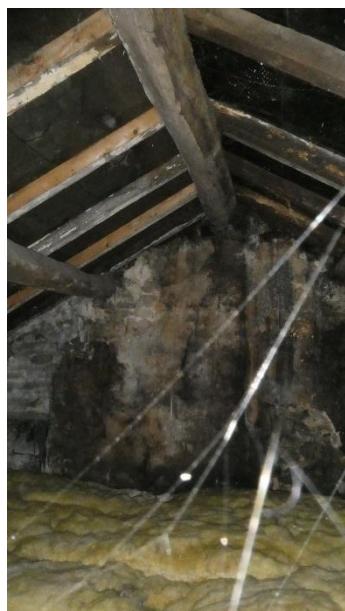
Figure 2 - Party wall/gable wall from within roof void

The chimney stack features a single clay pot to the front flue which serves the log burning stove within the reception room. The rear flue has been closed off by a square stone flag laid over the flue and bedded in mortar. It is expected that this would have originally served an open fireplace within Bedroom 1. The closed flue is not ventilated from inside or at the external capping. The lack of ventilation within a chimney flue can result in condensation forming inside the flue. The condensation is then absorbed by the surrounding masonry and can be drawn through to the outer face of the stone together with salts and soot from previous fires, leaving dark damp stains to walls or chimney breasts. Such dark stains were evident within the roof space below this chimney stack, with contrasting cleaner masonry in line with the flue which continues to serve the log burning stove (Figure 2). The use of the log-burning stove will help to dry the masonry along the line of the flue, thereby preventing this staining.

It was not possible to access the timbers to check their moisture content. The staining to the western gable wall (Figure 2 & Figure 37) was suggestive of water ingress and dampness through the chimney, roof covering and parapet above. This is discussed earlier in this report. Dampness from any water ingress may have affected the ends of the purlins and so when accessible, they should be checked for signs of damage.

For this reason, we would recommend that all disused flues be ventilated from both the top and bottom. This could be provided by adjustable vents fitted to blocked off fireplaces internally. Externally, the stone caps would need to be removed and a clay ventilated chimney cap instead fitted over the flues. These would need to be provided in keeping with the historical aesthetic of the building. The use of reclaimed clay chimney pots, either in a Bishop or Crown style would match existing pots and would likely be acceptable to the conservation officer. The chimneys should then be capped with a removable cap which allows ventilation into the flue while preventing birds/water ingress from above.

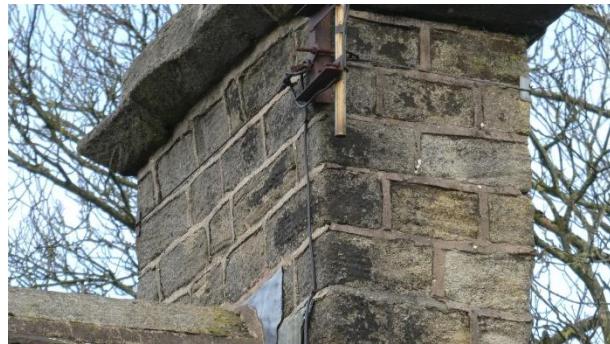
Figure 6 - Right, eastern, chimney stack

3. The third chimney stack to the right is formed as a continuation of the eastern gable wall. This is again formed from original stonework with stone copings proving a weathering projection to the top of the stack (Figure 6)

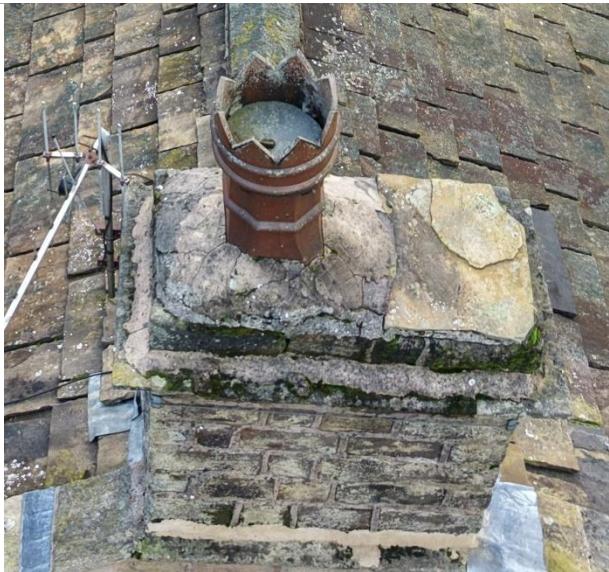
Figure 7 – Eastern most chimney stack

The chimney is provided with a 'crown' style clay chimney pot to the front flue with a stone cover over the rear of the chimney. The chimney would have originally served the fire place within the Lounge, however, this has again been blocked off internally and a cap has been added within the chimney pot to close the flue at roof level (Figure 7).

It was noted that the cement flaunching around the pot is cracking and friable. If left in this condition, the flaunching will begin to fall away. It is recommended that this be replaced at the earliest opportunity.

The joints in the stone of this chimney stack have been finished with 'strap pointing' – the application of modern cement based mortar over existing mortars. This was a common repair to older buildings but can be very damaging to masonry due to the strength of the cement mortar compared to the stone and the way in which the cement mortar traps moisture within the stone. The mortar was seen to be friable and breaking away in some locations, particularly again to the exposed western face (Figure 6). We would again recommend that the mortar of this chimney stack be raked out and the stack repointed in full.

Repointing to all chimney stacks should be undertaken using traditional lime mortars. The exact mix / colour should be agreed with the local conservation officer, but a natural hydraulic lime (NHL) mortar is likely to be most suitable for this position. The use of a 3.5 NHL lime is most common, but a more resistant 5.0 NHL lime could also be considered for greater resistance to the heavy weathering the chimney clearly receives. The use of cement based mortars should be avoided, as they prevent any moisture within the stone from freely evaporating allowing the stone to dry. This can result in the stonework being damaged by frost.

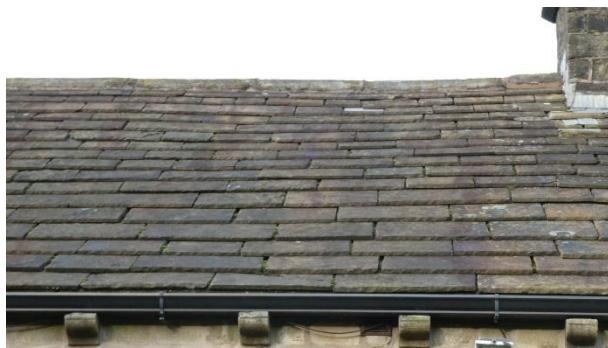
Figure 8 - Front roof slope

The property is covered by traditional stone slates laid in a diminishing course fashion. This means that the slates get smaller closer to the ridge of the roof. A small number of broken slates were identified to both the front and rear roof slopes (3No. to the front slope and 2No. broken slates to the rear slope). These should be replaced as soon as possible with reclaimed stone slates of similar sizes.

To the front roof slope, modern, adhesive flashings have been installed over some slates, presumably in an attempt to resolve issues with leaks due to slipped slates or where larger gaps are present between slates (Figure 8). No evidence of leaks to these positions were identified within the roof void, but the repairs would not be considered in keeping with the traditional roof finish.

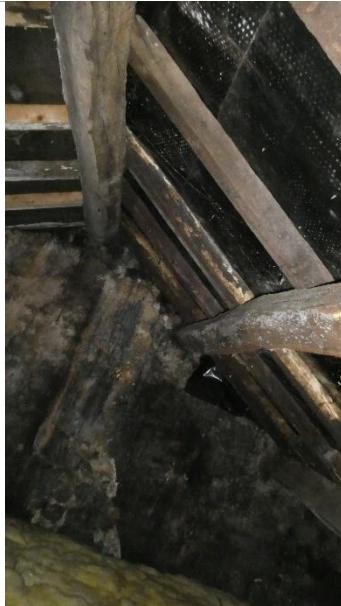
Figure 11 - Visqueen underlay over rafters

The underlay was seen to be hanging loosely within the roof space towards the western gable below the rear roof slope (Figure 11). Although no evidence of water ingress could be seen to the ceiling or bedroom wall below this point, the loose underlay would allow any water passing beyond the slates to drain into the roof void. Consideration should be given to repairing this affected area of the roof as soon as possible by lifting off slates above, then repairing, or replacing the affected section of underlay.

Although this repair and others mentioned could be undertaken over the next few years as and when further symptoms worsen, we note that the underlay used is not a breathable membrane and will not allow air or water vapour to pass through. The roof space should therefore be ventilated to prevent the build up of condensation forming. Condensation forms as warmer, humid air from within the property rises into the colder roof space.

In our opinion, the most suitable, and cost effective alternative to making numerous repairs would be to lift the existing roof coverings, retain and reuse slates where possible and recover the roof with a modern, air & vapour permeable (LR – Low Resistance) membrane. This should be installed with a reasonable 5-10mm drape between each rafter to allow any water passing beyond the slates to drain into gutters. This type of underlay would allow air passing between stone slates to ventilate the roof space. Retained slates should then be reinstated in the same diminishing course pattern onto new battens. Replacement reclaimed matching stone slates should be provided where required to replace damaged or broken units. This would allow other repairs to ridges and chimneys to be completed at the same time.

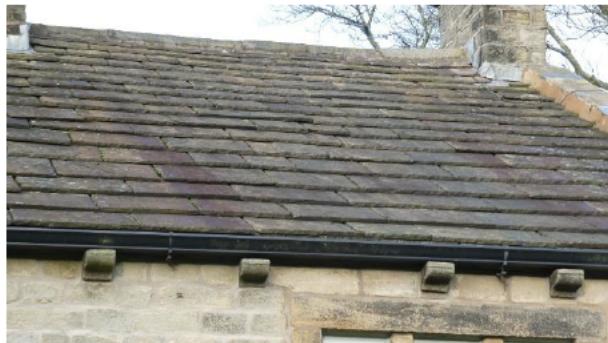
Figure 15 - Aluminium front gutter

The roof is served by aluminium gutters with an Ogee profile. These are supported on metal brackets above original stone gutter corbels. The stone corbels would have once supported timber guttering but now no longer serve a purpose other than to preserve the historical appearance of the building. These are specifically mentioned in the listed building description.

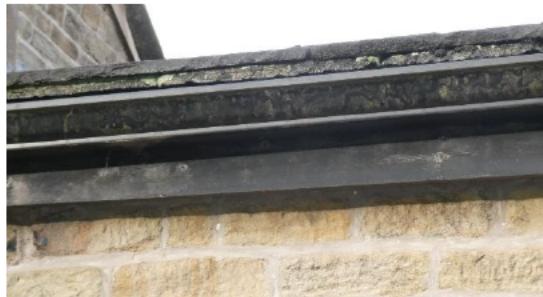
Figure 16 - Aluminium gutters to low level roof

Matching aluminium gutters also serve the low level roof over the kitchen/Bedroom 3 projection. These are fitted to timber fascia boards.

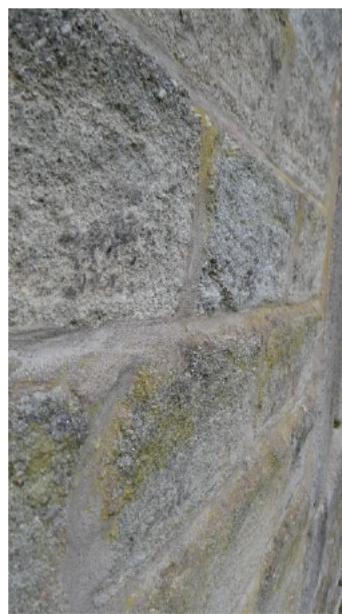
Figure 19 - Water-shot stone finish

The external sandstone is laid in a “water-shot” style, with each course laid at a slight tilt creating a “saw-tooth” appearance when viewed in section. This was common in the period of which the property was believed to have been built and helps to age the property. This style of construction was used to try and reduce internal dampness caused by the porous nature of the stone. The method was used to encourage any water absorbed into the stone to percolate down to the ledge at the bottom of the course and evaporate from there. The evaporation of moisture from the stone would also rely on the mortar encouraging a similar characteristic. For this reason, any repointing of the walls should only be done using traditional lime mortars.

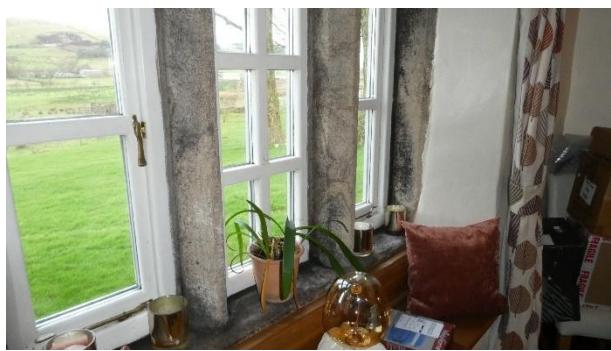
Figure 22 - Window opening internally

The opening casements feature horizontal central muntins. Internally, the casement windows are fitted with brass ironmongery in the form of window peg stays and handle fasteners.

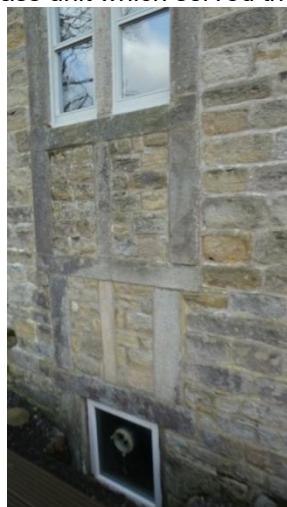
Figure 23 - Windows to centre of rear elevation

Four windows to the centre of the rear elevation provide light to the staircase internally. The lower two windows are fixed with horizontal muntins, while the upper two windows are opening casements matching others.

There are stone surrounds below these windows suggestive of previous window openings which have been blocked up in the past. Below this is a single, uPVC framed, double glazed window with a plastic ventilator set within the glass unit which served the cellar of the property.

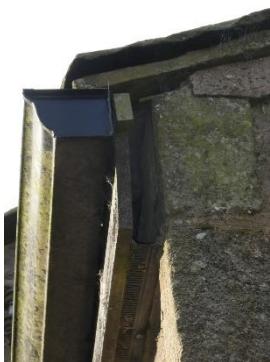
Figure 28 - Open end of fascia at eaves

The ends of the fascia were also seen to be open. Although any water entering this opening would drain out of the ventilated soffit below, the opening would likely encourage insects / rodents / birds to enter the construction at this point. We would therefore recommend that the open ends of the fascia to both the front and rear verge of this roof be closed off with a steel or fibreglass insect mesh.

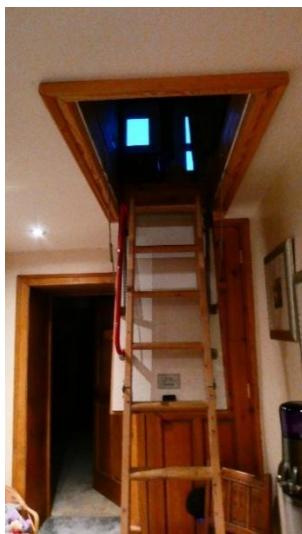
Figure 30 - Ceiling hatch at first floor level

The main roof is accessed via an insulated timber ceiling hatch with a folding timber loft ladder fitted to the ceiling of the first floor landing.

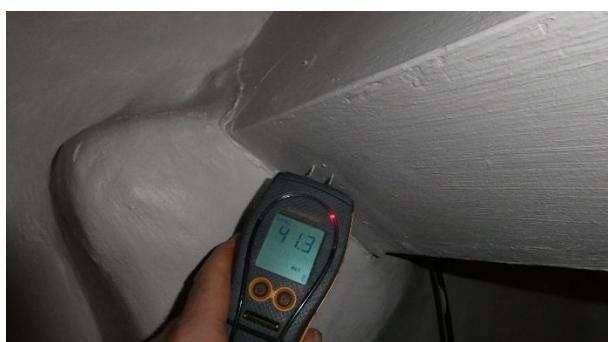
Figure 31 - Purlin supported on larger stone to gable wall

The timber purlins are exposed in the Attic Room and Storage area. The purlins above the Attic Room are supported on the gable wall and the internal stone wall between the Attic and Storage room. There are projecting larger stones below some of the purlin ends to help spread the load of the purlins (Figure 31).

Timber purlins above the Attic Room have been painted and so appeared to be in a reasonable condition. There was no evidence of infestation of the timber but the ends of the purlins where they are supported on the walls were tested with a Protimeter Surveymaster damp meter. This revealed elevated moisture content of up to 62% (to the central ridge beam). The purlins to the rear provided lower readings and the moisture content of all beams reduced significantly as the distance from the gable wall increased. Due to the porous nature of the stone, it is common for moisture to be absorbed into timber which is supported within the wall. Modern methods would recommend that timber ends be wrapped in Visqueen to prevent them being affected by moisture.

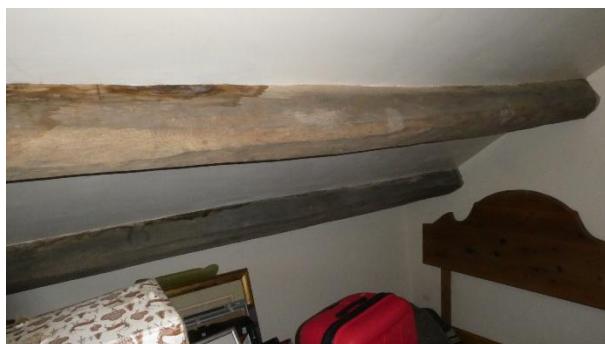
Figure 33 - Timber purlins to Storage area

The purlins within the central Storage area were again exposed. These are supported on the internal wall and continue through the timber stud partition into the roof void beyond where they are supported on a timber king-post truss just beyond the stud partition (Figure 33 & Figure 32).

Timber purlins within the Storage area have not been painted. Although flight holes consistent with woodworm could be seen, there was no evidence (frass) seen which would be indicative of an ongoing infestation. We therefore believe that the timber is free from invasive insects.

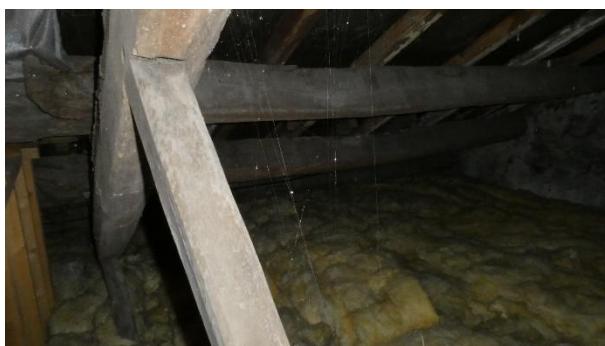
Figure 32 - Purlins supported on timber truss in roof void

Through this hole, it could be seen that the timber king-post truss supports additional purlins up to the western gable wall (party wall) (Figure 32).

Levels of insulation within the property could not be determined except for within the roof void where a single layer of mineral wool quilt insulation was seen to be laid over the ceiling joists (Figure 32). Due to the lack of access, it was not possible to measure the depth of insulation laid over the ceiling. Modern ceilings would be offered with around 300mm of insulation, laid in two layers. We would therefore recommend that an additional layer of mineral wool quilt insulation be laid over the existing when access is next made into the roof void to help reduce heat loss through the roof.

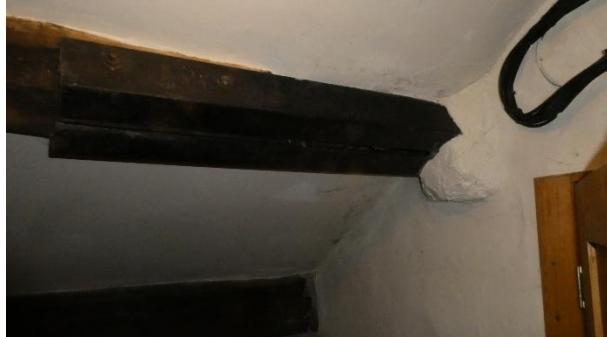
Figure 35 - Steel encasement to rear purlin

The bearing end of the higher purlin below the rear roof slope was seen to be encased in steel. Looking through the gaps in the steel it could be seen that the end of the purlin has rotted and become very soft.

This type of strengthening work is typical where there is a requirement to preserve the historical timber of a building while continuing to provide strength to support the roof above. It is likely that during works to restore the property, a specialist survey was undertaken on the historical timber elements to assess their structural capacity and identify repairs which may be required to preserve them such as this. We would recommend that your legal adviser enquire with the vendor if any information is available regarding the historical timber within the property or if a previous report has been provided.

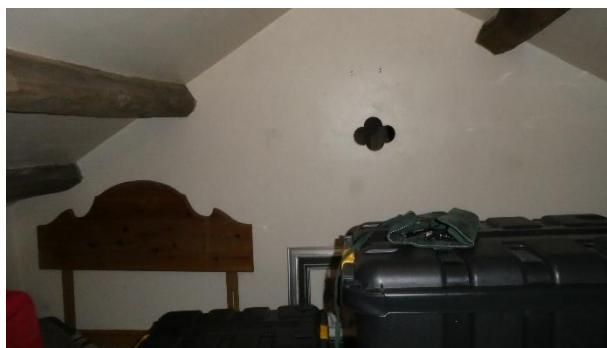
Figure 36 - Hole in stud partition allowing observation into roof void

It was not possible to access the remaining roof void beyond the timber stud partition. It was only possible to make visual observations of the roof void through a small hole in the plasterboard of the partition (Figure 36).

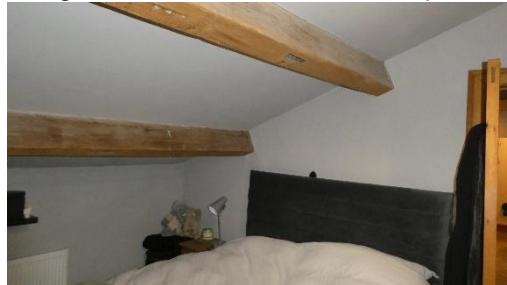
Figure 39 - Bedroom 3 sloping ceilings

Similar plastered sloping ceilings have been formed between purlins in Bedroom 3.

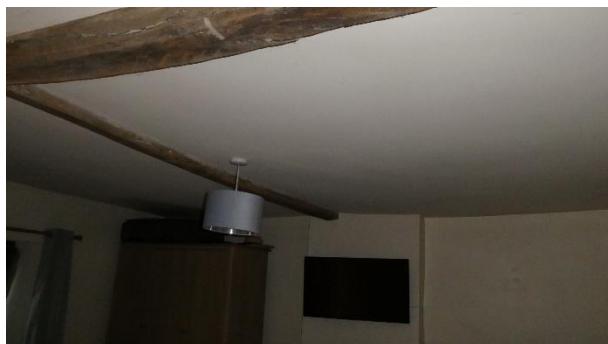
Figure 40 - Master bedroom ceiling with timber truss seen

The underside of the timber roof truss and intermediate timber girders could be seen within Bedroom 1 and Bedroom 2.

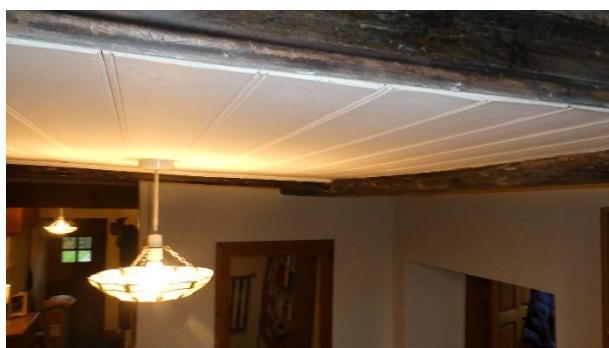
Figure 43 - T&G cladding to ceiling at base of stairs

The timber cladding within the circulation area is separated by timber beams at the base of the staircase. The beams were noted to be formed from older timber which could well be original. Speculating; the cladding could be covering an original ceiling construction above which was considered an important historical element of the building but which could not be economically repaired. The installation of the timber cladding may therefore have been a requirement of the conservation office/planning department when the building was renovated to provide a refreshed ceiling while preserving the historical construction above. This may need to be considered if any adaptations are to be considered to the entrance hall (e.g. wiring of lighting).

The T&G cladding at the base of the stairs was noted to be uneven. This is likely to be due to the surface to which it covers and again indicates the likely covering of an original ceiling. The local conservation officer may have records of the ceiling construction.

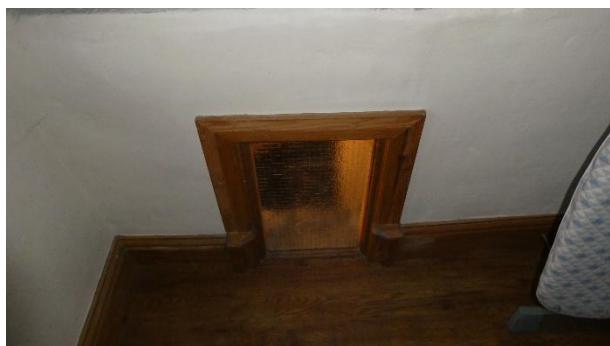
Figure 45 - Low level window within WC

There is a small window at low level to the stone partition between the ground floor WC and the staircase into the cellar.

Due to the low level of this window, it is at risk of impact from accidental kicking or similar damage. The glazing of this window was noted to be Georgian Wired. Although this will help to give added strength to the glazing, the glazing may still shatter upon impact. Consideration should be given to replacing the glazing within this window with modern toughened glass which will break into smaller, safer pieces if impacted.

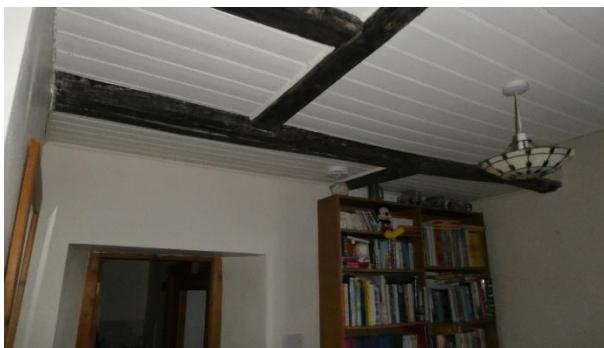
Figure 47 - Historic timber girders to base of stairs

The exposed timber was seen to be of a varying age/style, with darker timber seen to the perimeter of the staircase, and supporting the first floor landing area (Figure 47). These are considered likely to be original elements of the building with significant historical value.

These timber elements were seen to be uneven and the first floor finish above this area reflected this with an uneven finish particularly noted when entering the rear bedroom (Bedroom 4). Although it was not possible to lift the carpet finish of the landing to inspect the condition of the floorboards, we do not believe this to be a defect with the floor, simply the age related character of the construction. The limitations this historic construction offers are considered in Section I4.

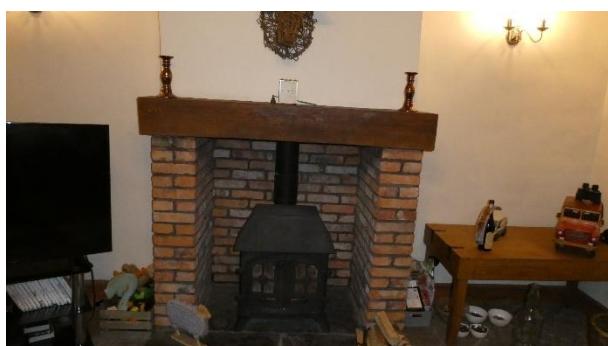
Figure 48 - Log burning stove within Reception Room

The fireplace has been rebuilt using brickwork and the opening of the chimney supported by a concrete lintel.

The log burner appeared to be functional but was not in operation at the time of the inspection. We would recommend that a HETAS certificate be obtained confirming the installation of this appliance meets the requirements of the Building Regulations.

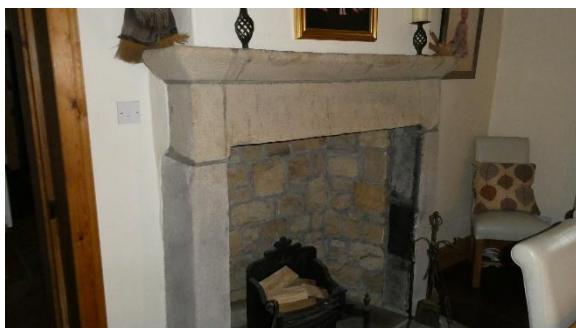
Figure 50 - Dining Room fireplace

The fireplace within the Dining Room is in a typical location for a property of this age, where a central fireplace would have been formed against the circulation space to provide heat to the centre of the property. This again helps to confirm the age of the property. This fireplace has a stone surround and stone hearth.

The stone has been cleaned and the flue blanked off. It was therefore not possible to observe the condition of the flue above. The fireplace would likely be ideal for the installation of a log burning stove if desired as it does not feature any combustible materials, although the condition of the flue and chimney would need to be checked. This is considered in Section D1 of this report.

If log burning stoves are desired, we would recommend that a HETAS approved engineer be appointed to inspect the condition of the flues throughout their length and consider the potential for installing new flue liners into the flues to serve the desired stoves. It is noted that this would need to be undertaken in line with the works recommended to the chimney in Section D1 of this report.

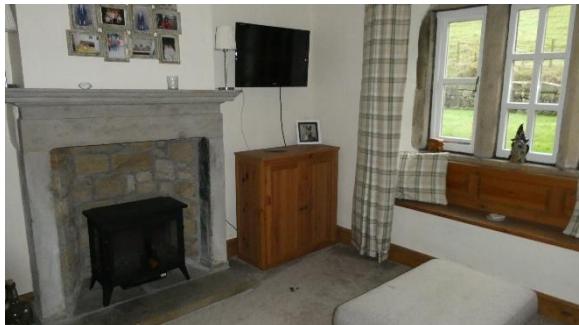
Figure 51 - Lounge

The fireplace within the Lounge has also been closed off, and an electric imitation stove has been fitted within the fireplace.

Again, this fireplace is formed from stone and is likely to be original, although the stone mantelpiece piece appears to be newer and may have been replaced in the past. Again, the flue of this fireplace has been blanked off internally but the fireplace should be suitable for the installation of a log burning stove if desired and depending upon the condition of the flue.

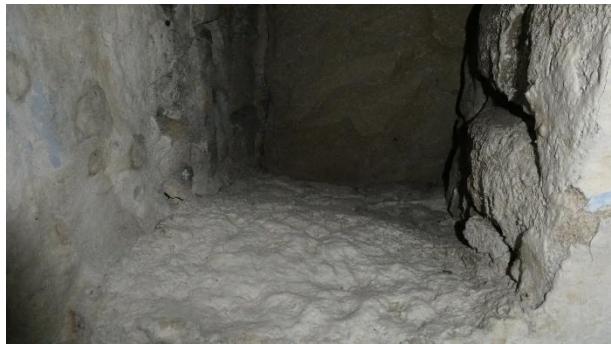
Figure 52 - Flue within cellar capped with stone

The underside of a flue could be observed within the cellar of the property. Looking up through this flue from the underside, it could be seen to be capped with a stone flag at ground floor level. It was not possible to observe this stone at ground floor level.

It is assumed the property originally featured a fireplace within the cellar which has been removed a long time ago. It would be preferable for unused flues to be ventilated to try and reduce the risk of condensation forming within the flues. This is discussed in Section D1 of this report but it is appreciated that this may not be possible to achieve from within the cellar. Introducing ventilation to this flue at the chimney stack is recommended.

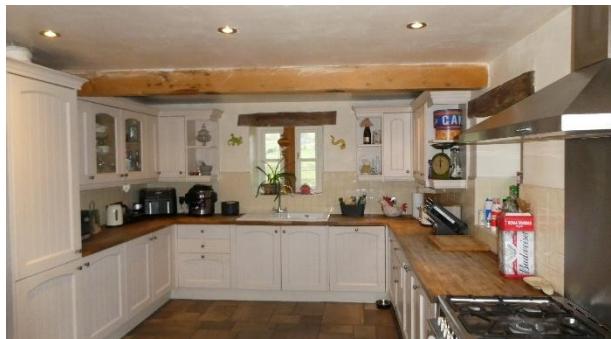
Figure 53 - Kitchen units

The kitchen was found to be in a used but serviceable condition. The solid timber nature of the units fitted will make the kitchen very hard wearing, but marks to the inside of cupboards were noted. The kitchen features an electric oven with an LPG fire gas hob over. There is a stainless steel splashback behind the oven extending up to a stainless steel extractor fan. The appliances were not tested as part of this inspection. It is recommended that you satisfy yourself with the condition of appliances which are to be included as part of the sale, in particular you should appoint a Gas Safe Registered engineer to test the LPG appliances prior to use to ensure they are safe.

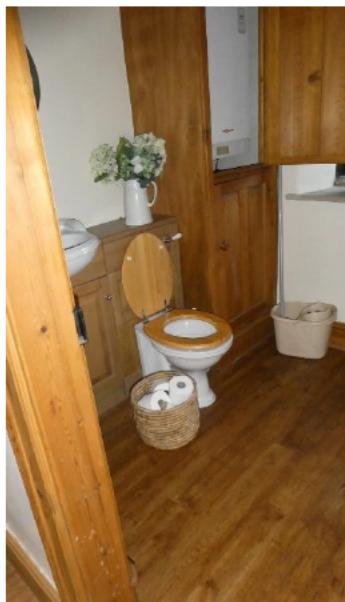
Figure 54 - Ground floor WC cloakroom suite

There is a timber cloakroom vanity suite providing a small cupboard below the wash hand basin and enclosing the cistern of the WC within this room. Again, these were found to be in a reasonable condition.

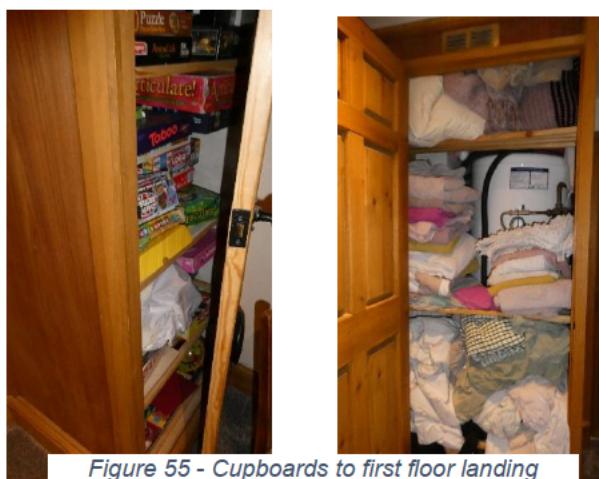
Figure 55 - Cupboards to first floor landing

There are two timber, full height cupboards formed to the first floor landing area. One of these is used for storage only, while the other encloses the hot water cylinder. This second cupboard is provided with ventilation at high level and low level to reduce the risk of condensation forming within the warmer cupboard. Both cupboards were found to be in a reasonable condition but belongings within both cupboards significantly restricted inspection within the cupboards.

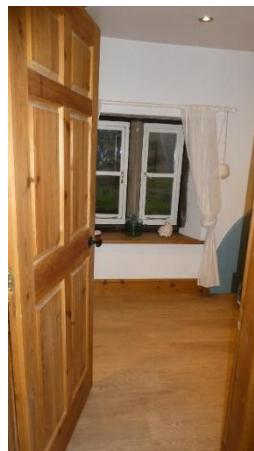
Figure 56 - Panel doors with knobs and keeps

The property is fitted with solid timber panel doors throughout. These are fitted with oval door knobs and surface mounted keeps. It was noted that the planning permission granted for the renovation of the property required internal doors to be restored and so these doors may be original.

Doors were generally serviceable but due to the solid timber nature, they have experienced warping to a number of openings. Some doors have suffered from this worse than others. Solid timber doors are susceptible to this due to changes in humidity and temperature. For minor warping, as found to doors such as the Master Bedroom & Bathroom, adjustments can typically be made to the hinges and keeps to allow the door to be closed again easily.

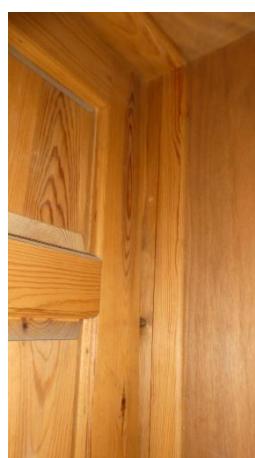
Figure 57 - Warped door to Dining Room

More significant warping of doors, as seen between the Kitchen and Dining Room.

Due to this, it was not possible to close the door.

The same issue was found to the door into the Lounge. In such instances, it may require the door to be slowly flattened over time. It may be considered easier to replace the door, but due to the expected historical value of the doors, this is unlikely to be accepted by the local conservation officer. We would initially recommend you appoint a joiner to review what adjustments can be made to such doors.

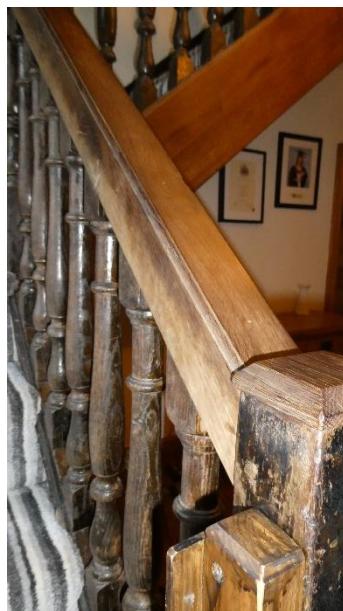
Figure 60 - Historic balustrading to staircase

The staircase and first floor landing are protected by a hardwood balustrade. The balustrade is anticipated to be original, or at the very least it is very old. Repairs have been made to the closed string at the side of the stairs and the handrails have been encased in newer material. This has a contrasting grain and finish to the spindles and strings of the staircase/balustrade.

The lower section of the balustrade, leading up from the ground floor was noted to be loose. This could pose a significant safety risk should anyone fall on the stairs and rely on the handrail/balustrade for support as it may give way under significant load. It is therefore recommended that the balustrading be repaired at the earliest opportunity. Given the historical interest the balustrade holds, repairs should be made in traditional methods and will require the skills of a joiner experienced in heritage repairs. The cost for this could be significant and would be difficult to estimate. It is recommended you seek quotations from a specialist joinery firm for this work.

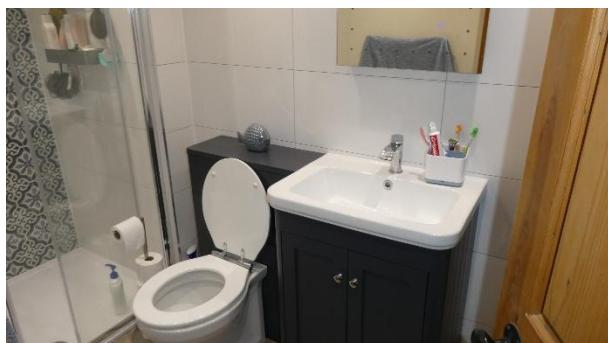
Figure 61 - Master Bedroom en-suite

The Master Bedroom en-suite is provided with a modern close coupled WC with matching wash hand basin both set within a timber cloakroom suite. These again were found to function as expected. The en-suite features a large shower cubicle with a ceiling mounted rainfall shower unit connected to a shower mixer on the wall. The shower tray is lined with a wall cladding and tiles. The shower was turned on and found to operate and the shower cubicle closed as expected.

The clean nature of the silicone indicated the recent re-tiling or re-sealing of the shower in this room. As evidence of a leak had been identified to the main entrance hall below this area, it is assumed that works have been undertaken to resolve this. The ceiling and wall below were now found to be dry and so the leak is expected to have been resolved as no cause of a leak was evident. If the leak is found to continue in the future, we would recommend that the drainage from the shower tray be investigated, although this would require the shower cubicle to be dismantled.

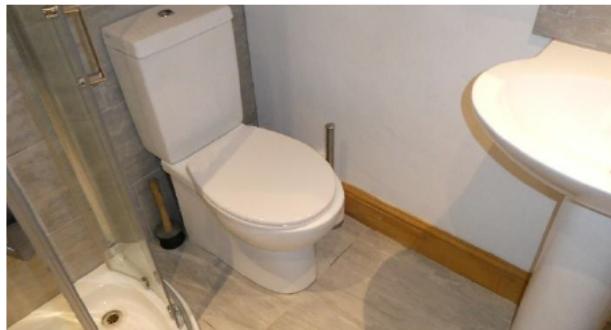
Figure 62 - Bedroom 2 en-suite WC

The WC was found to have a broken flush mechanism. There was also evidence of the toilet becoming blocked. This may be due to the restricted flush as the push-button flush may only be operating with a more economical light flush. Once the flush mechanism is repaired, blockages to the toilet may reduce.

The seat of the toilet pan was also found to be loose.

We would recommend that a plumber be appointed to replace the internals of this cistern and fix the flushing mechanism. If blockages continue to occur, the drainage from the toilet may need to be investigated further.

While attending, the plumber should look to re-secure the seat to the pan or replace the seat if necessary.

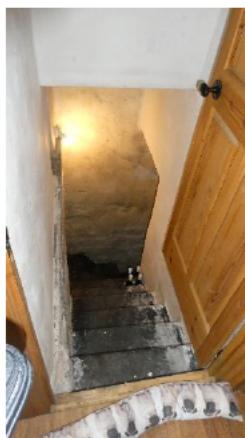
Figure 63 - Staircase to cellar

The property features an original cellar. This is accessed via a stone staircase leading from the utility room into the cellar. The staircase is not provided with a handrail, and is considered narrow by modern standards. Care should be taken when accessing this cellar for this reason. Consideration may be given to installing a lock to the door at the head of the staircase to prevent unsupervised access to the cellar by young children.

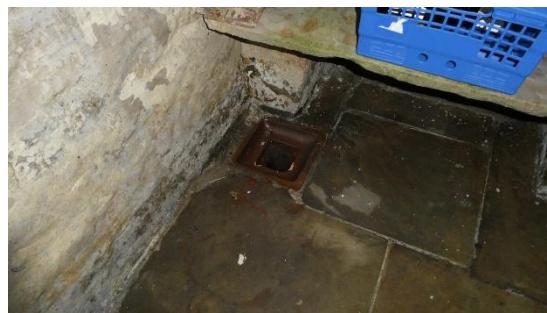
Figure 65 - Drainage gully to floor of cellar

The floor of the cellar is formed from stone flags. At the base of the rearmost wall, a clay gully is set within the floor for drainage. The floor slabs were seen to be visibly saturated and it is assumed they are laid directly onto the soil below.

There is a clay gully in the floor of the cellar (Figure 65) which was seen to be partially blocked. This should be cleared of debris to facilitate water drainage from the cellar.

The gully to the rear of the room should help to facilitate the drainage of the cellar should water levels begin to rise. To prevent significant flooding, it is recommended that the gully and connected drain be kept clear. A visual inspection of the gully suggested it may be partially blocked and so we would recommend that the gully and drain be checked and jetted clear where required.

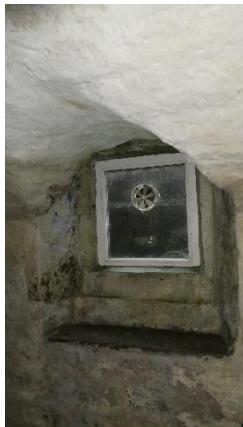
Figure 66 - Window of cellar

The walls of the cellar were also evidently damp, with water damage particularly noted to the reveals of the window opening.

The floor of the cellar is around 1.6 metres below the external ground level. There is therefore likely to be significant hydrostatic pressure from ground water on the outside of the walls which will force water through the porous stonework into the cellar. The same will apply vertically up through the floor. During periods of wet weather, the quantity of water in the ground will increase as water runs towards the property from surrounding higher fields. This will increase hydrostatic pressure and increase the quantities of water entering the cellar. For this reason, the cellar could not be considered a habitable space and careful consideration should be given for what is stored within this room.

Due to the constant moisture entering the cellar, walls and floors are likely to remain damp at all times. Combined with the lack of heating, this will cause condensation and mould to form. This could be seen at low levels and has resulted in some of the limewash finish flaking to walls, particularly around the window opening. The limewash could be re-applied throughout to provide a fresh finish to the cellar if desired. Modern paints should be avoided as they will not allow the moisture within the walls to evaporate through them freely.

If the desire were to utilise the cellar to provide additional habitable space (e.g. for an office or similar), significant work would be required to manage the levels of moisture entering through the surrounding structure. The use of a drained cavity basement lining system would help to allow water to drain through the walls and floors to a channel drain connected to the existing drainage system. A pump may be required to help manage drainage during periods of wetter weather.

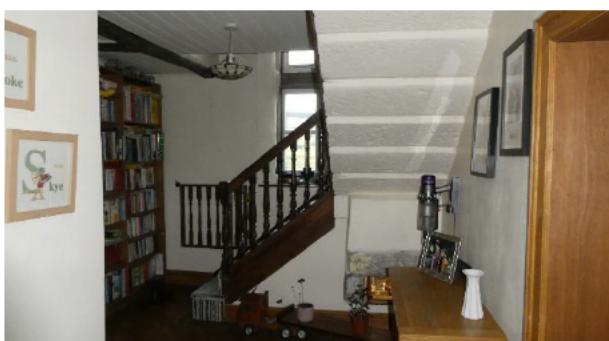
Figure 67 - Stone staircase

The main staircase of the property is constructed from stone with a carpet finish over.

There were no signs of movement or defects noted with the stone stair construction.

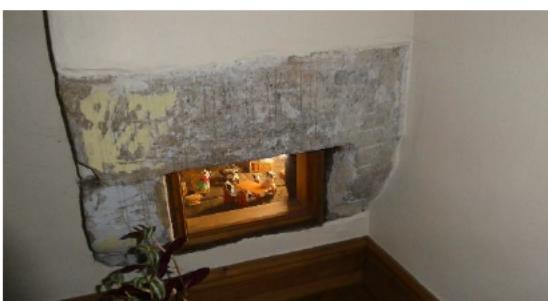
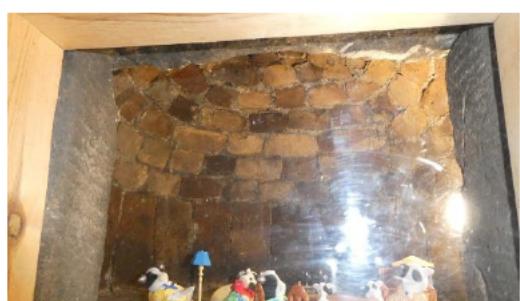
Figure 68 - Historic brick void beneath stairs believed to be an old bread oven

There is a small void below the staircase which has a significant stone surround to a small glazed window. Looking through the window, there is an arched void lined with brickwork. This is not a feature we have witnessed before. Following extensive research, we believe this to be an original bread oven. A small fire would be lit within this brick dome to heat up the brickwork. The debris of the fire would then be removed and bread put in to bake from the radiant heat retained by the bricks.

It is not recommended that this be reinstated for this purpose but the historic element has been retained in a sympathetic way.

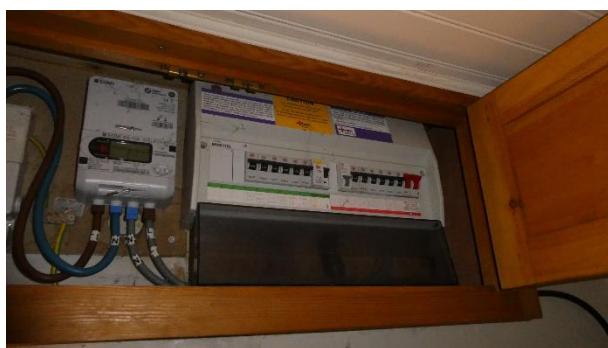
Figure 69 - Consumer unit within main circulation space

Mains electricity is connected via an overhead supply feeding an older 100Amp mains fuse within the electrical cupboard at high level within the main entrance hall. The mains supply then feeds into a modern digital electric meter which in turn supplies a modern consumer unit. The consumer unit (CCU) features modern MCB and RCD protection to circuits. The CCU was marked as having been inspected last in October 2008. We estimate that this is the date at which the CCU was installed. It is recommended that your legal adviser obtain copies of any up to date electrical test certificates for the property.

Despite the relatively new nature of the installation, we would recommend that a full electrical test be undertaken by an NICEIC approved electrician to determine the suitability and safety of the electrical systems within the property unless a recent test certificate can be obtained by your legal adviser.

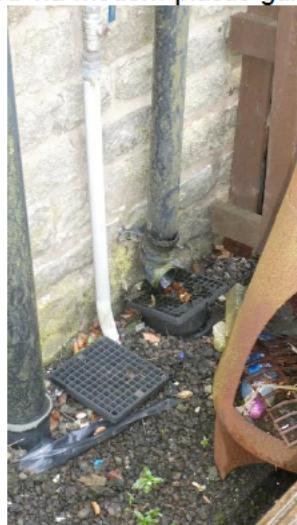
Figure 72 - Raised gullies to rear

Gullies to the rear elevation were seen to be positioned higher than the surrounding ground.

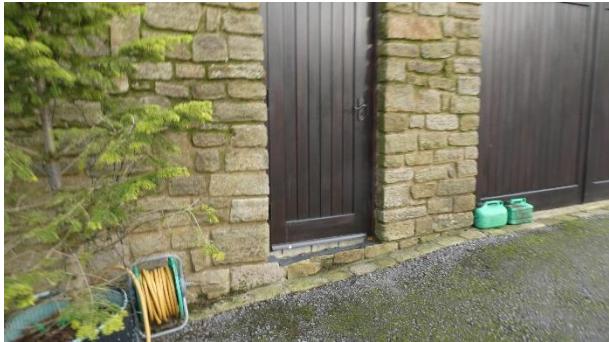
Figure 74 - Personnel door to garage

The external walls of the garage are built off a modern Visqueen DPC. This could be seen to extend over the opening of the personnel door where the door has not been fitted with an external threshold. It is recommended that the cavity be closed at this point with a new threshold.

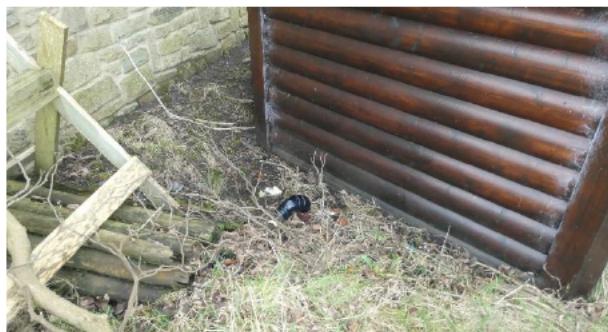
Figure 75 - Pipework to ground behind BBQ hut

Around the hut, pipework was seen to protrude from the ground.

It was not clear what these pipes served. We assumed they provide ventilation to a feature below the BBQ hut. Further investigation would be required to determine the purpose of these pipes. It is recommended you seek further information from the vendor about this via your legal adviser.

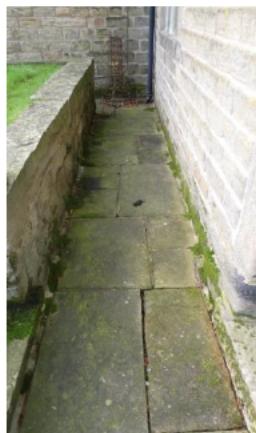
Figure 79 - Front path

The front garden is generally laid to lawn with a stone path leading from the front gate to the property. The lawn and path are considered serviceable. The path leads to stone steps down towards the main front entrance of the property as the front garden is raised above the path at the base of the front elevation. The garden is retained by stone walls. These retaining walls create a drop of 700-800mm which lacks any form of handrail to prevent people falling from the front garden down to the stone path. This safety factor may be considered unsafe, particularly if young children were to play on the front garden. A low level fence could be added around this garden to reduce the risk of falls.

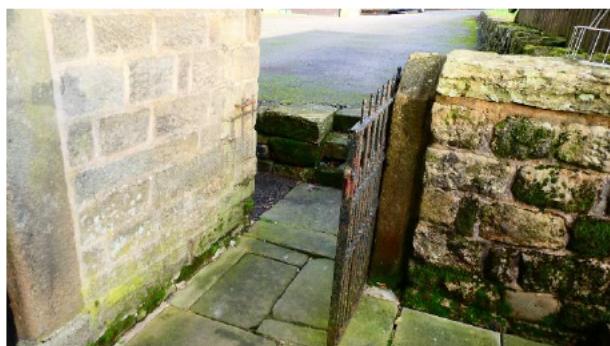
Figure 80 - Gate from driveway to front of property

The front path is separated from the driveway by another wrought iron gate. This gate is in a better condition but is of a similar age to the gate at the front of the property. The gate could not be closed due to the position of the keep fitted to the external wall of the kitchen. Adjustment of the keep is required if there is a desire to close this gate.

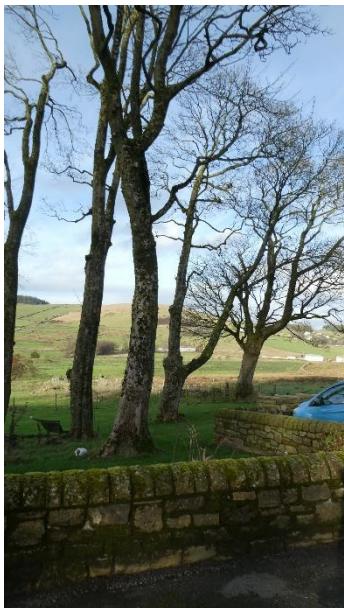
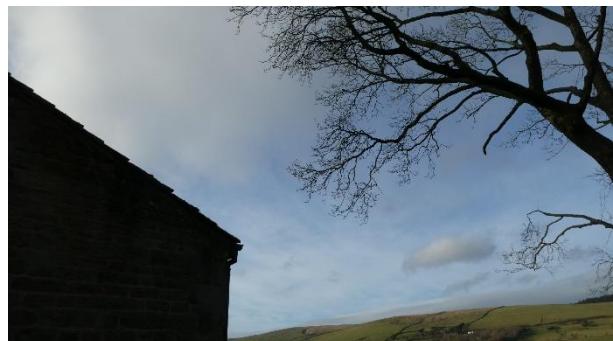
Figure 82 - Cluster of trees within rear garden

There are a further eight trees clustered together within the rear garden.

Again, we would recommend that the trees be assessed for their condition and safety by an arboriculturist.
